CONTRACT QUALITY ASSURANCE AND PRICING  
PRACTICES FOR PATRIOT MISSILE PROCUREMENTS

Report No. 95-252

June 26, 1995

**SUBJECT: Audit of Contract Quality Assurance and Pricing Practices for Patriot  
Missile Procurements (Project No. 4CF-8020)**

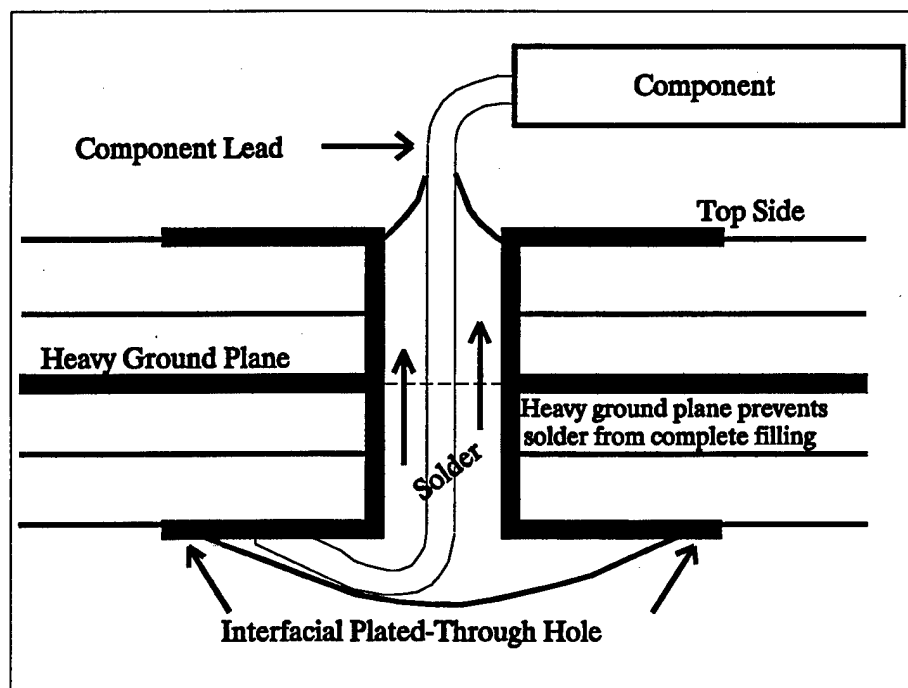
**Multilayer Circuit Boards.** Patriot guidance systems contained 39 multilayer circuit boards and the related ground units contained 1,760 similar boards. Those multilayer circuit boards were formed by compressing from 2 to 16 single-layer circuit boards into one unit. They were further formed by connecting the interfacial plated through-holes of a single-layer circuit board to through-holes of the other single-layer circuit boards in the multilayer unit. As depicted on page 4 of this report, electronic components are inserted in the plated through-holes and connected by osmotically flowing the solder from the bottom toward the top of the multilayer circuit boards.

**Cross Section View of Upward Solder Flow Through a Multilayer Circuit Board**

**Audit Results.** The allegation was substantiated. Raytheon did not completely solder the electrical connections to the top side of those circuit boards according to contract requirements. However, no adverse impact was determined. When MICOM determined that the contract requirements were not met, it issued a contract waiver relieving Raytheon from that requirement to avoid delays in the delivery of the Patriots.
